Fireline

Triangle 100 Years Later

BY GABE F. MIEHL, CSP, CFPS

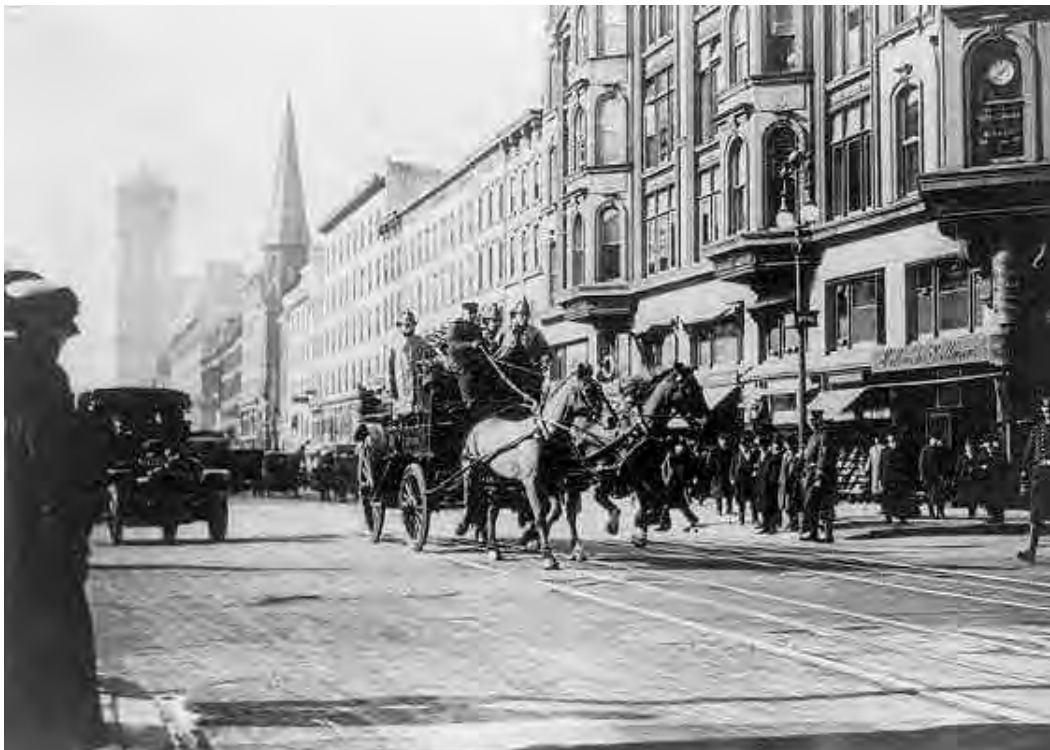
ABOVE PHOTO: HORSE-DRAWN FIRE ENGINES EN ROUTE TO THE TRIANGLE SHIRTWAIST FACTORY FIRE.
