Volume 2 Number 3

Fall 2007

## Loose Flange Bolts at PSV Cause Fire

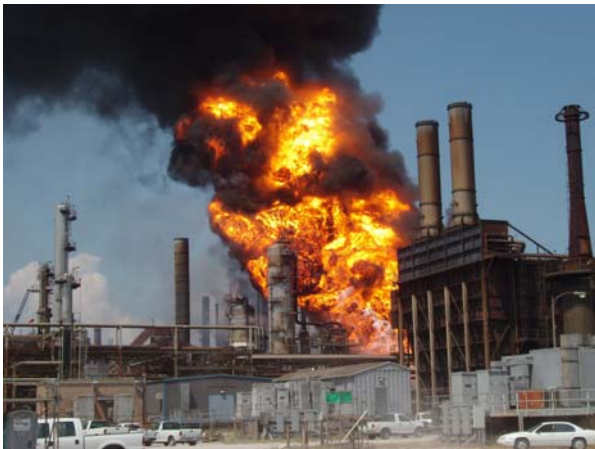
A crude unit at Chevron's Pascagoula refinery experienced a large and costly fire in August 2007. The official investigation report has not yet been issued, but the likely scenario of events leading up to this fire has been informally reported as follows:

- A 4" x 6" or 6" x 8" PSV was removed for routine servicing at last TA, but when it was reinstalled, the flange bolts were not properly tightened (maybe only hand-tightened).
- The PSV was not easy to access. The loose PSV inlet flange probably leaked a small amount for quite some time, but the small leak was not detected due to the PSV's location.

- Sometime well after TA, the PSV started "simmering" due to system pressures getting close to the PSV set pressure.
- The simmering of the PSV was just the "right frequency" such that loose stud nuts backed off the studs and some nuts fell off completely.
- With missing and very loose nuts, the flange opened up enough to cause a significant release and fire.

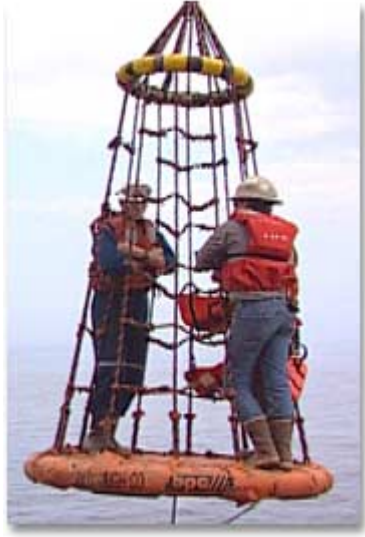
- **Outer protection:**

The outer rigging could now be tightened with the use of a center coupling that provided riders with protection from outer strikes such as handrails or other obstructions.

- **Man-**

**positioning attachment:** It was determined in the evaluation process that a “man-positioning” system would be best for this application. Almost everyone surveyed emphasized that full fall protection was too constraining for offshore transfer. This new system was developed to allow the rider to incorporate a quick-release lanyard that provided protection from falling out but still allowed passengers (by pulling the quick release) to move rapidly away from the unit when necessary.
